## COMMERCIAL WINDSTORM MITIGATION INSPECTION REPORT (OIR-B1-1802)

Lake Heather Heights Condominium Association, Inc  
2370-2377 Lake Heather Heights Ct  
Dunedin , FL 34698

As of 3/27/2014

## **RECAPITULATION OF MITIGATION FEATURES** **For 2370-2377 Lake Heather Heights Ct**

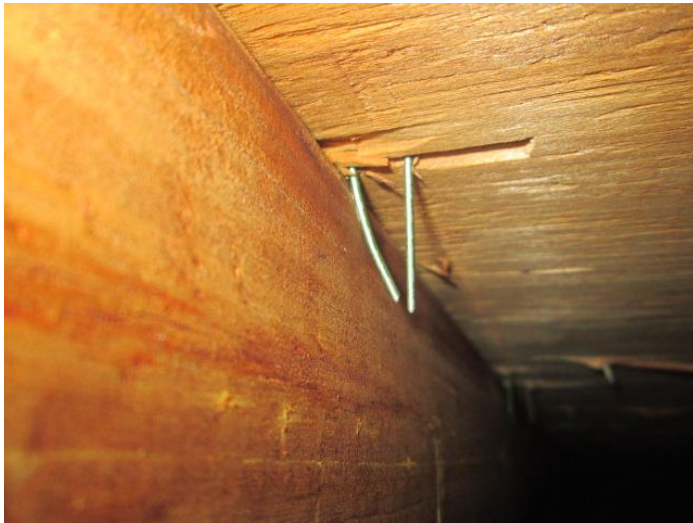
Roof Deck Attachment

| 3. <b><u>Roof Deck Attachment:</u></b><br>Comments: | <b>Level A</b><br>Inspection verified 1/2" plywood roof deck attached with staples at a minimum of 6" on the edge & 12" in the field. |

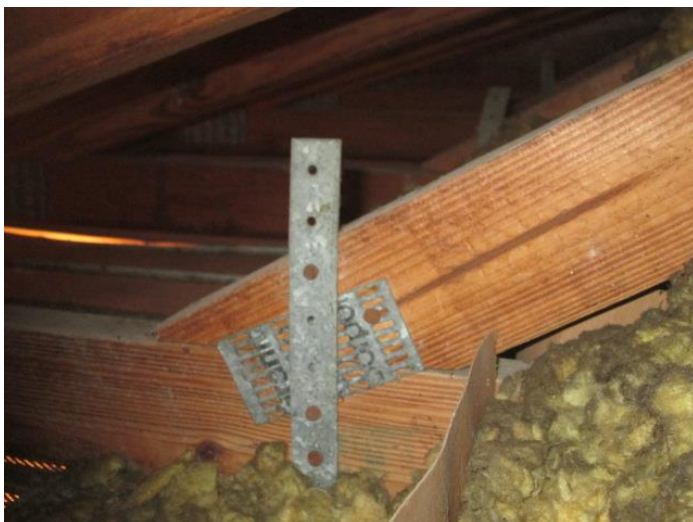
Roof to Wall Attachment

| 4. <b><u>Roof to Wall Attachment:</u></b><br>Comments: | <b>Clips</b><br>Inspection verified embedded straps fastened with a minimum of three nails. |

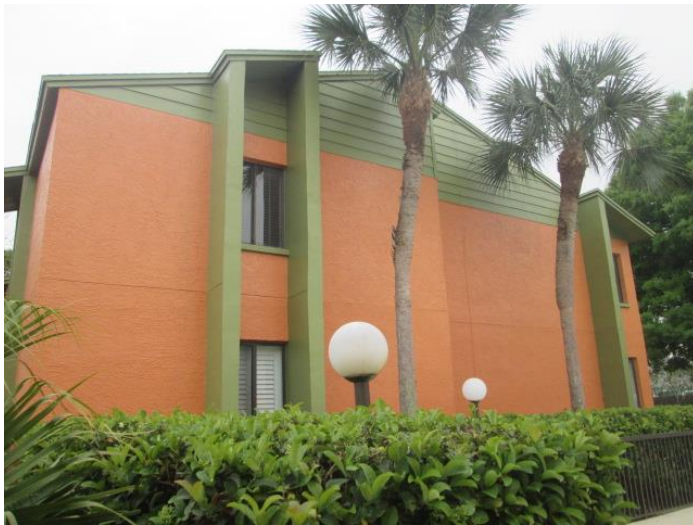
Roof Shape

| 5. <b><u>Roof Geometry:</u></b><br>Comments: | <b>Other Roof</b><br>Inspection verified a gable roof shape. |
