COMMERCIAL WINDSTORM MITIGATION INSPECTION REPORT

Lake Heather Heights Condominium Association, Inc.

COMMERCIAL WINDSTORM MITIGATION INSPECTION REPORT (OIR-B1-1802)

RECAPITULATION OF MITIGATION FEATURES
For 2310-2325 Lake Heather Heights Ct

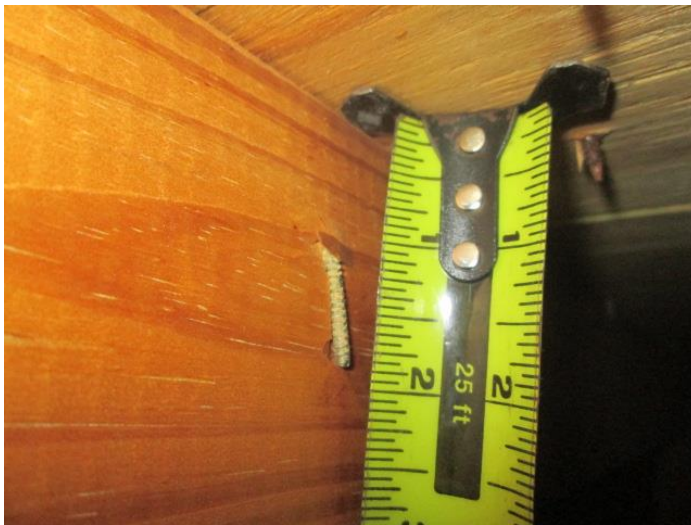
Roof Deck Attachment

3. **Roof Deck Attachment:** **Level C**
Comments: Inspection verified 1/2" plywood roof deck attached with 8d nails at a minimum 6" on the edge & 6" in the field.

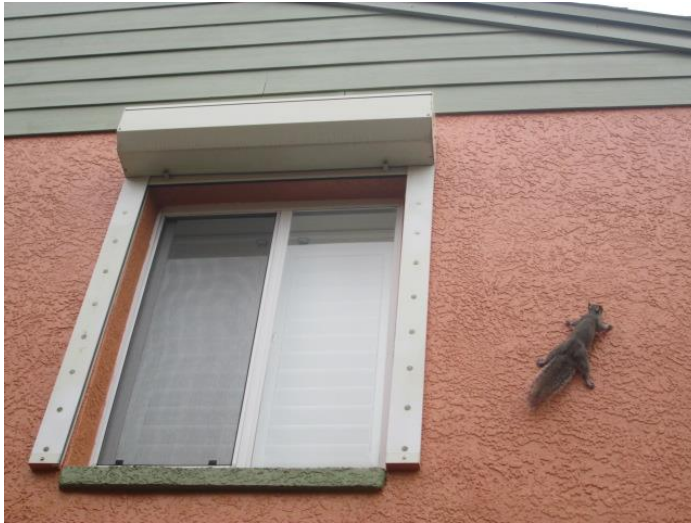
Some Opening Protection

7. **Opening Protection:** **None or Some Glazed Openings**
Comments: Inspection verified some metal shutters.

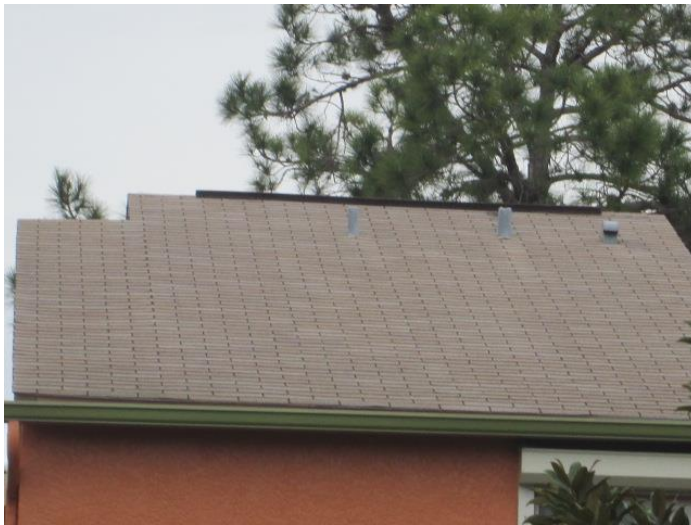
Roof Covering

2. **Roof Covering:** **FBC Equivalent**
Comments: The roof covering is original to the construction of the building in 2002, no permit information was found with the local Building Department. This roof was verified as meeting the requirements outlined on the mitigation affidavit.

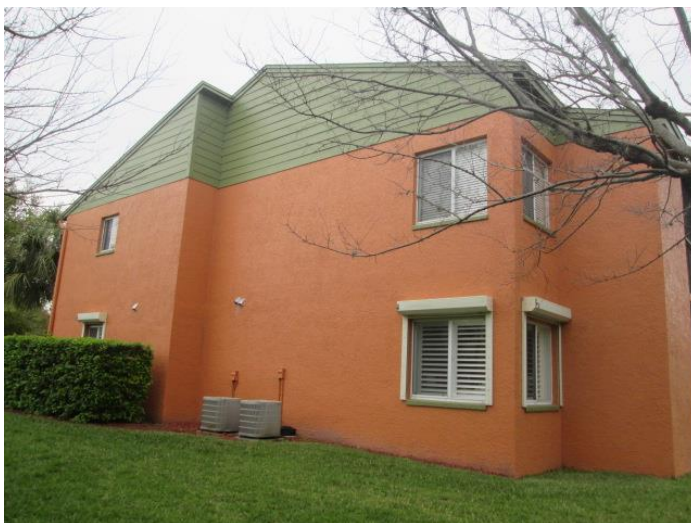
Roof Shape

5. **Roof Geometry:** **Other Roof**
Comments: Inspection verified a gable roof shape.

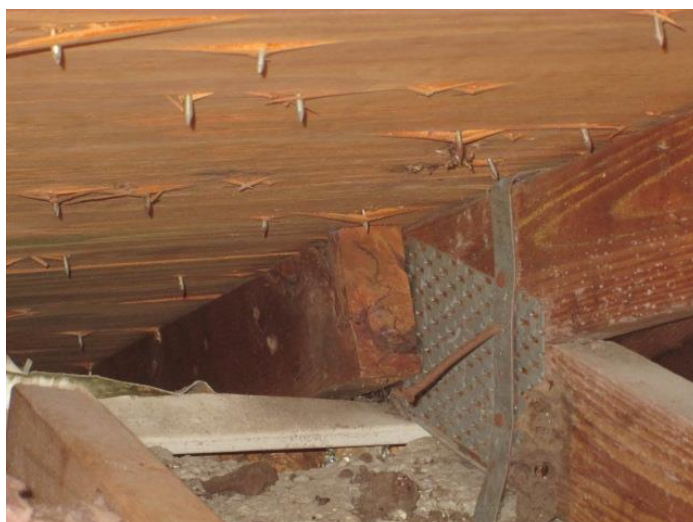
Roof to Wall Attachment

4. **Roof to Wall Attachment:** **Clips**
Comments: Inspection verified embedded straps fastened with a minimum of three nails.
5. **Roof Geometry:** **Other Roof**
Comments: Inspection verified a gable roof shape.

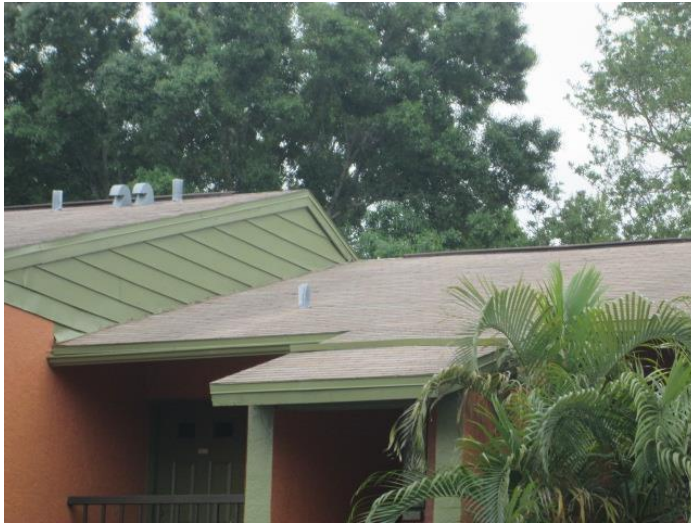
Roof Covering

2. **Roof Covering:** **FBC Equivalent**
Comments: The roof covering was replaced in 2003. The roof permit was confirmed and the permit number is 03-2551. This roof was verified as meeting the building code requirements outlined on the mitigation affidavit.

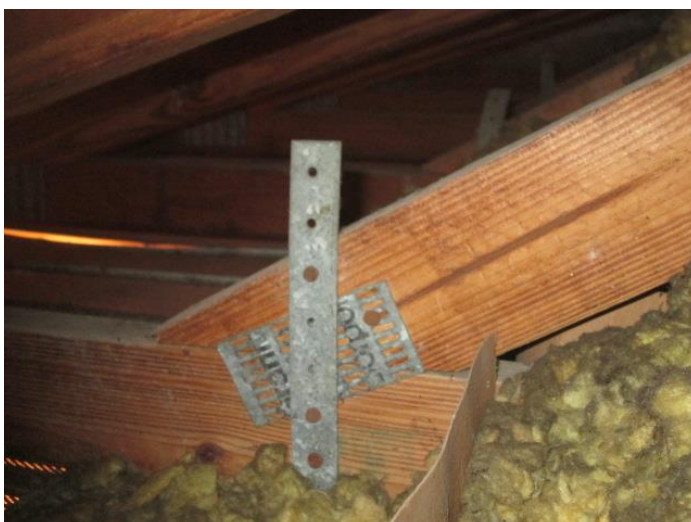
Roof to Wall Attachment

4. **Roof to Wall Attachment:** **Clips**
Comments: Inspection verified embedded straps fastened with a minimum of three nails.
5. **Roof Geometry:** **Other Roof**
Comments: Inspection verified a gable roof shape.

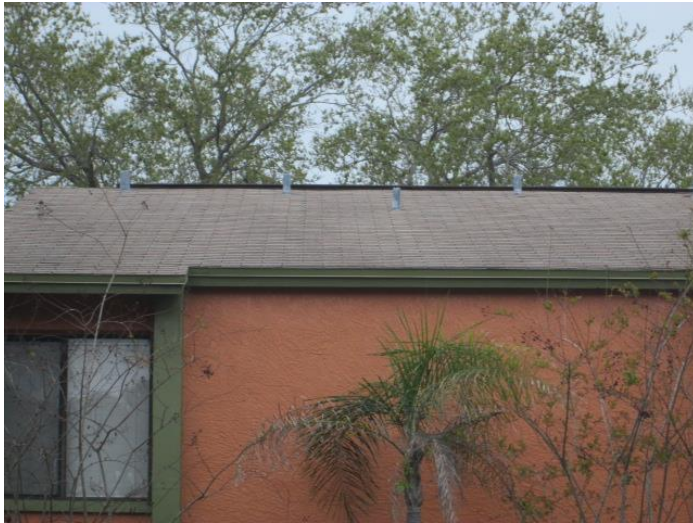
Roof Covering

2. **Roof Covering:** **FBC Equivalent**
Comments: The roof covering was replaced in 2003. The roof permit was confirmed and the permit number is 03-2552. This roof was verified as meeting the building code requirements outlined on the mitigation affidavit.

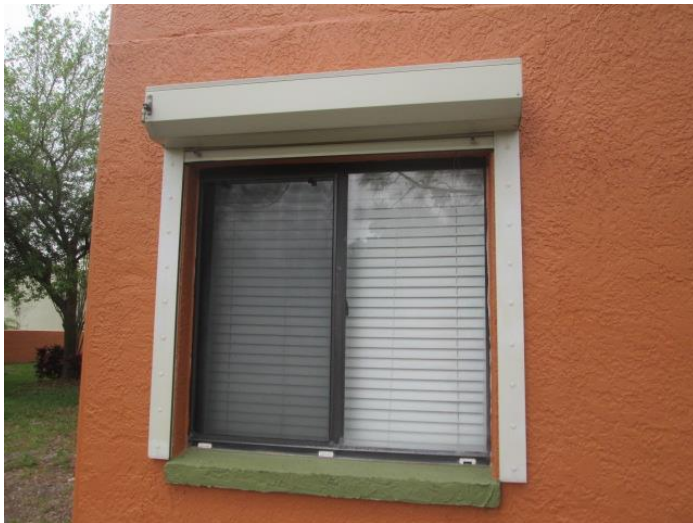
Some Opening Protection

Comments: | None or Some Glazed Openings
Inspection verified some metal shutters. |

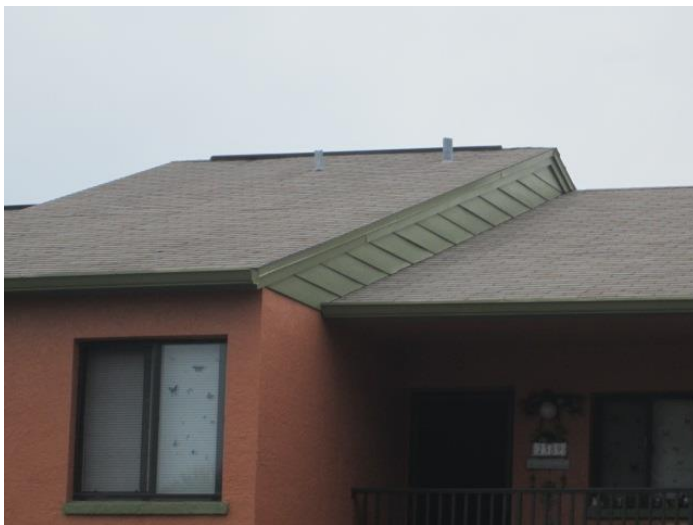
Roof Covering

Comments: | FBC Equivalent
The roof covering is original to the construction of the building in 2002, no permit information was found with the local Building Department. This roof was verified as meeting the requirements outlined on the mitigation affidavit. |

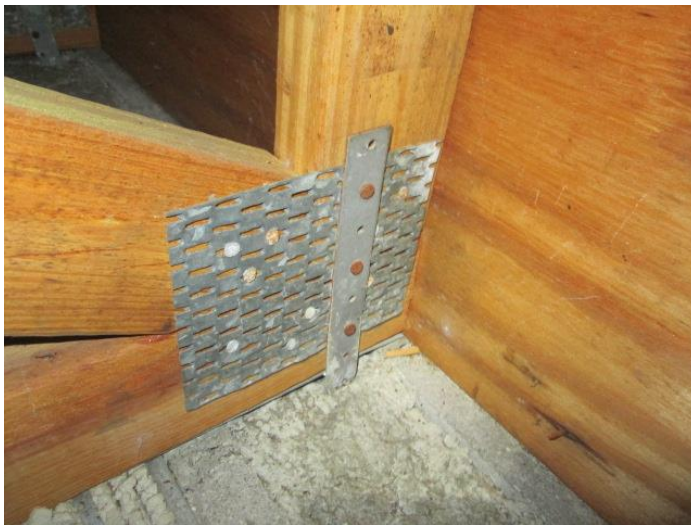
Roof to Wall Attachment

4. **Roof to Wall Attachment:** **Clips**
Comments: Inspection verified embedded straps fastened with a minimum of three nails.
5. **Roof Geometry:** **Other Roof**
Comments: Inspection verified a gable roof shape.

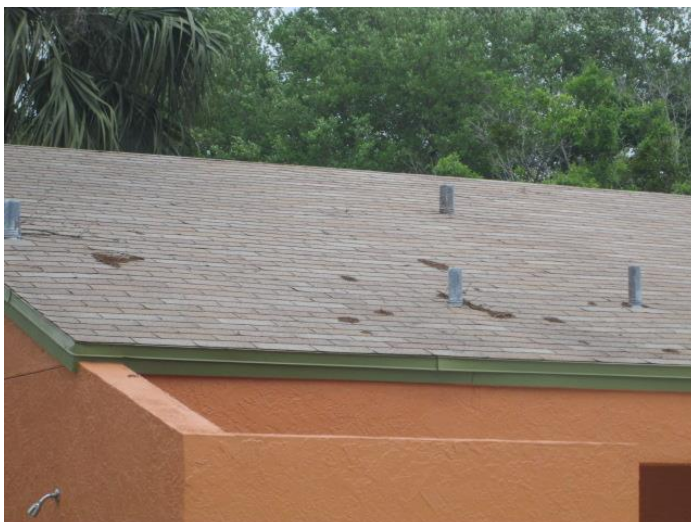
Roof Covering

2. **Roof Covering:** **FBC Equivalent**
Comments: The roof covering was replaced in 2003. The roof permit was confirmed and the permit number is 03-2553. This roof was verified as meeting the building code requirements outlined on the mitigation affidavit.
